## A problematic hotel

What happens when a Dubai hotel undergoes structural movement leading to water penetration in the basement? In this case, Casagrande undertakes micropiling in the hotel's basement

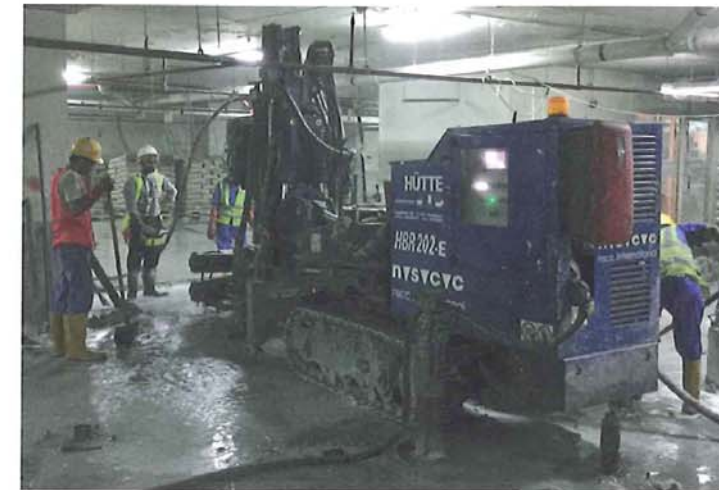
*Due to limited space and health and safety concerns, an all-electric Hütte Bohrtechnik rig was used in the basement of a Dubai hotel suffering from structural movement*

All the drilling and injection works was executed from the second basement which had restricted headroom; just 2.5m. Both the confined space on site and the health and safety concerns regarding the fumes forced the contractor to use all-electric machinery, including the low-headroom electric drill rig from Hütte Bohrtechnik – the Hütte HBR 202 E. The compact machine features a telescopic mast that can extend up to 2.7m high with a powerful rotary of 2.8tm torque.

Drilling of all 312 micropiles and the 582 tube à manchette pipes was done using just the one machine working in double shifts.
