# Re-opening the iconic Highway 1

After heavy rain caused mudslides which closed sections of the iconic Highway 1 in California, drilling equipment supplied by Hütte Bohrtechnik was used to stabilise the slopes above the road

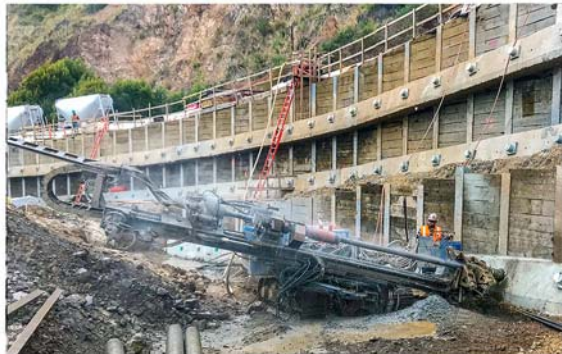
*A Hütte Bohrtechnik rig was used during slope stabilisation work on Highway 1 in California after heavy rain caused mudslides*

It was planned for the project to average approximately two holes per day with two machines. However, when it switched to using one Hütte Bohrtechnik HBR 605 drill rig with double head HG28/HG13 the average went up 2-3 holes per day with one machine only.

Using 219mm x 2m casing with 114.3mm outside diameter x 2m, 3.5in API REG rods with a 6in DTH hammer with a button bit casing crown the contractor was able to install 300 anchors at drilled depths of 30-35m. ▼
